IRRIGATION BEST PRACTICE
WATER USE OPTIMISATION
PROJECT 1717C

Final Report

Project title: Irrigation Best Practice – Water Use Optimisation

Vineyard Irrigation Best Practice – Optimisation Project

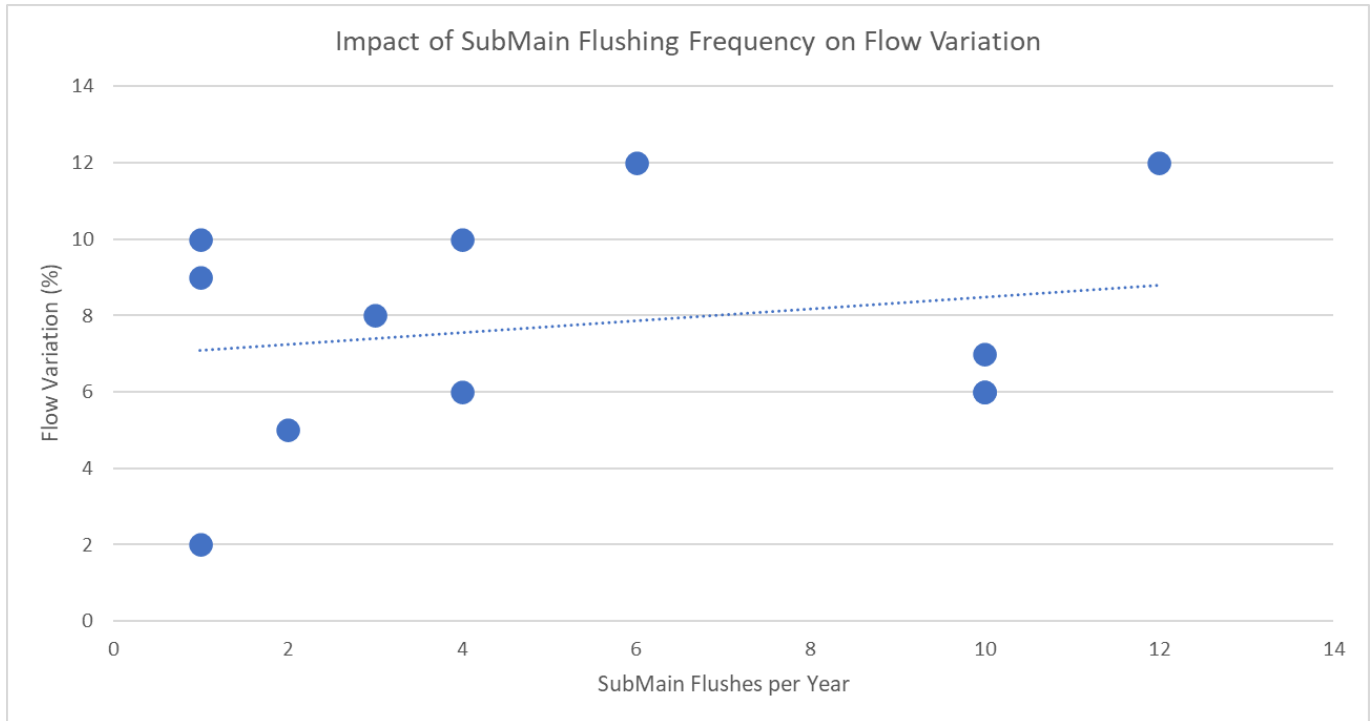
The comparison of maintenance measures with flow variability produces more complex results. The trend line for frequency of submain flushing (*Figure 7*) indicates a positive relationship with flow variation, indicating that flow variation increases as submain flushing frequency increases. This is opposite to what could be expected; that flushing foreign material out of the system will reduce the potential for clogging and therefore maintain consistent dripper flow rates.

Figure 7 Correlation between frequency of submain flushing and flow rate variation

It should be noted that the two systems with the highest variability are 16 and 18 years old, so their poor performance is more likely related to their age than to their high flushing frequency. Also, water quality contributes to the need for flushing, so ideal flushing frequency may vary between sites depending on where their water is accessed and what treatment it receives before it is delivered to the valve unit. Even different positioning of pump intakes within the river can impact the amount of foreign material in the water, and therefore its impact on the irrigation system.

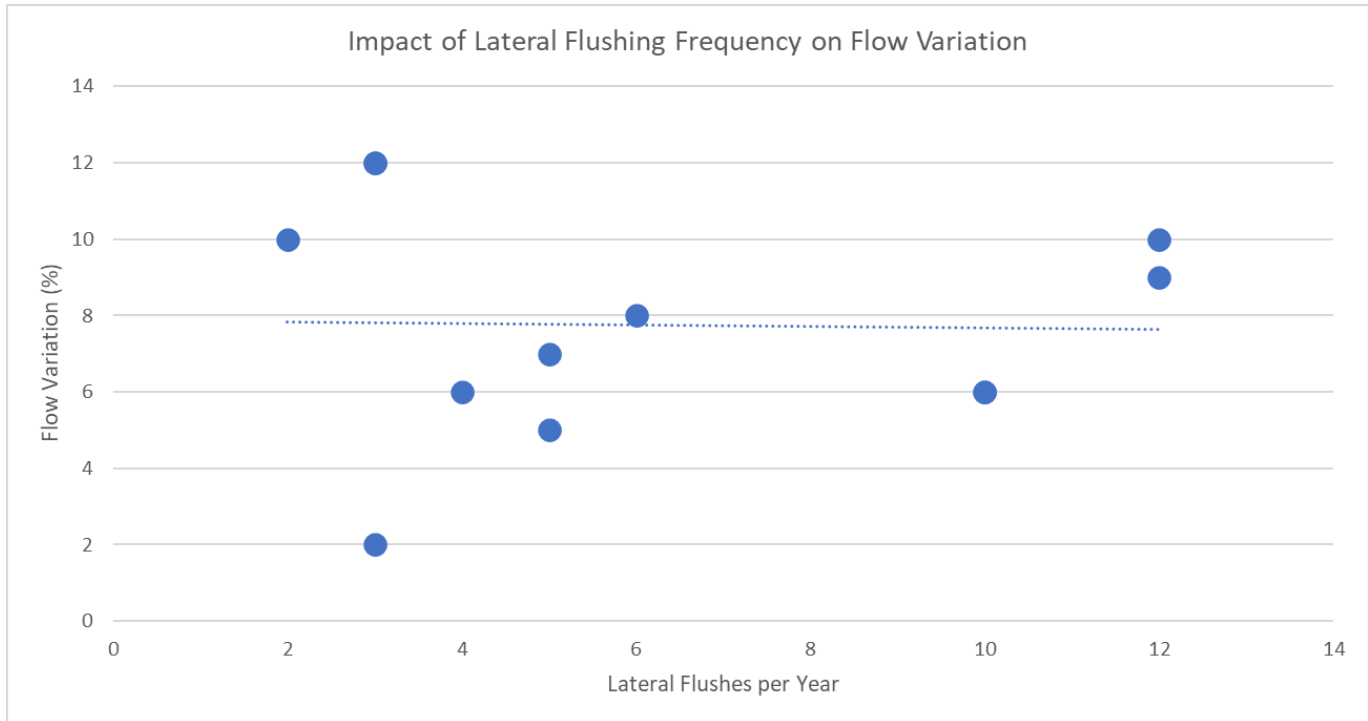
The relationship between lateral flushing frequency and flow variability is almost flat (*Figure 8*), suggesting no relationship between frequency of flushing of laterals and system performance. Again, this conclusion is counter-intuitive, and suggests that other factors are at play in this relatively small sample.

Figure 8 Correlation between frequency of lateral flushing and flow rate variation
